Public Submission for The City of Warrenton, Oregon

Planning Commission Meeting, April 13, 2023

City File No: V23-1 for Hardship Variance Application at property address 590 7th Avenue, Hammond, OR

By Lisa Halicki, 598 7th Court, Hammond, OR

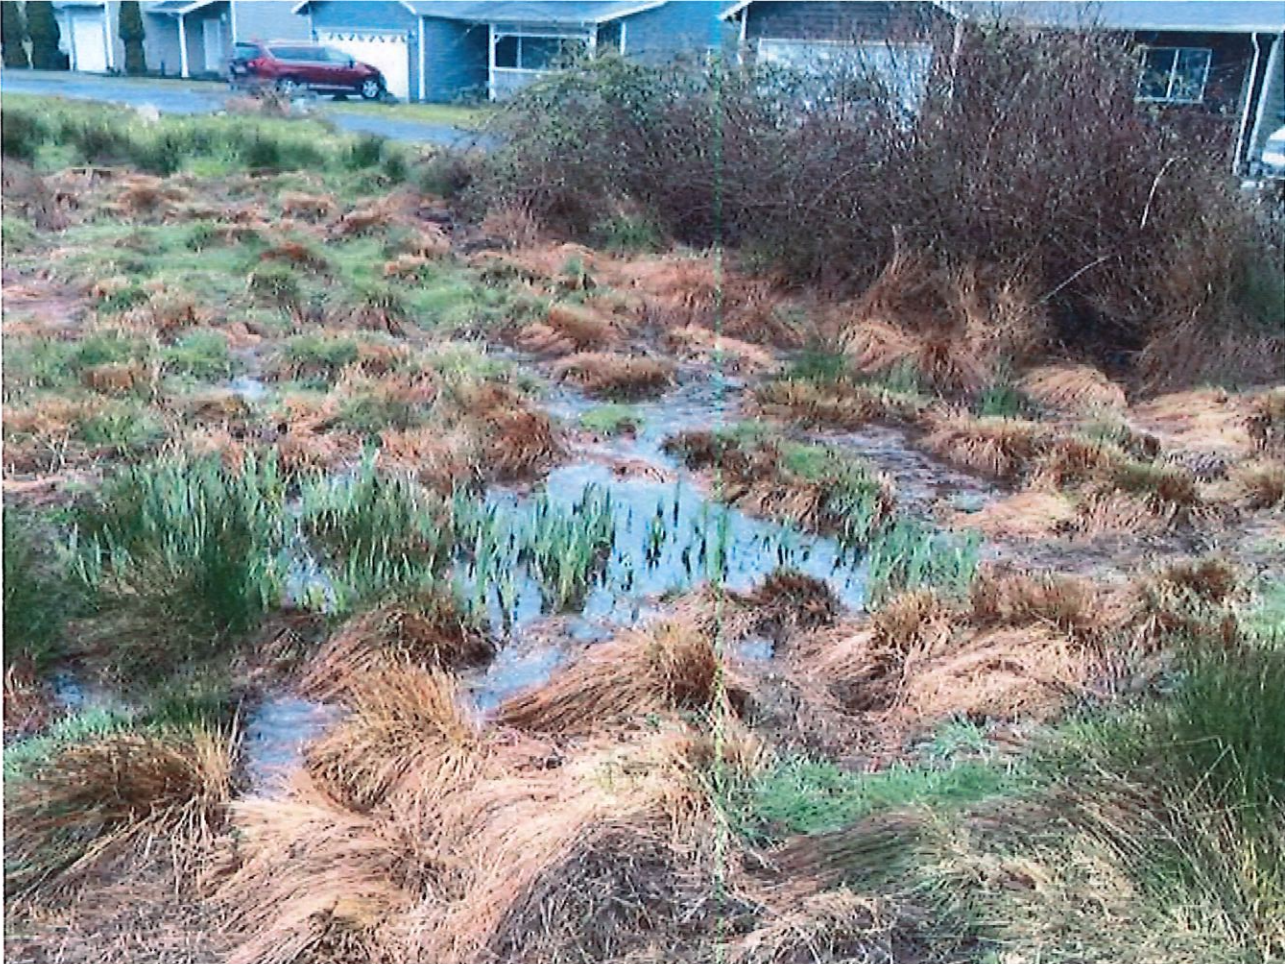
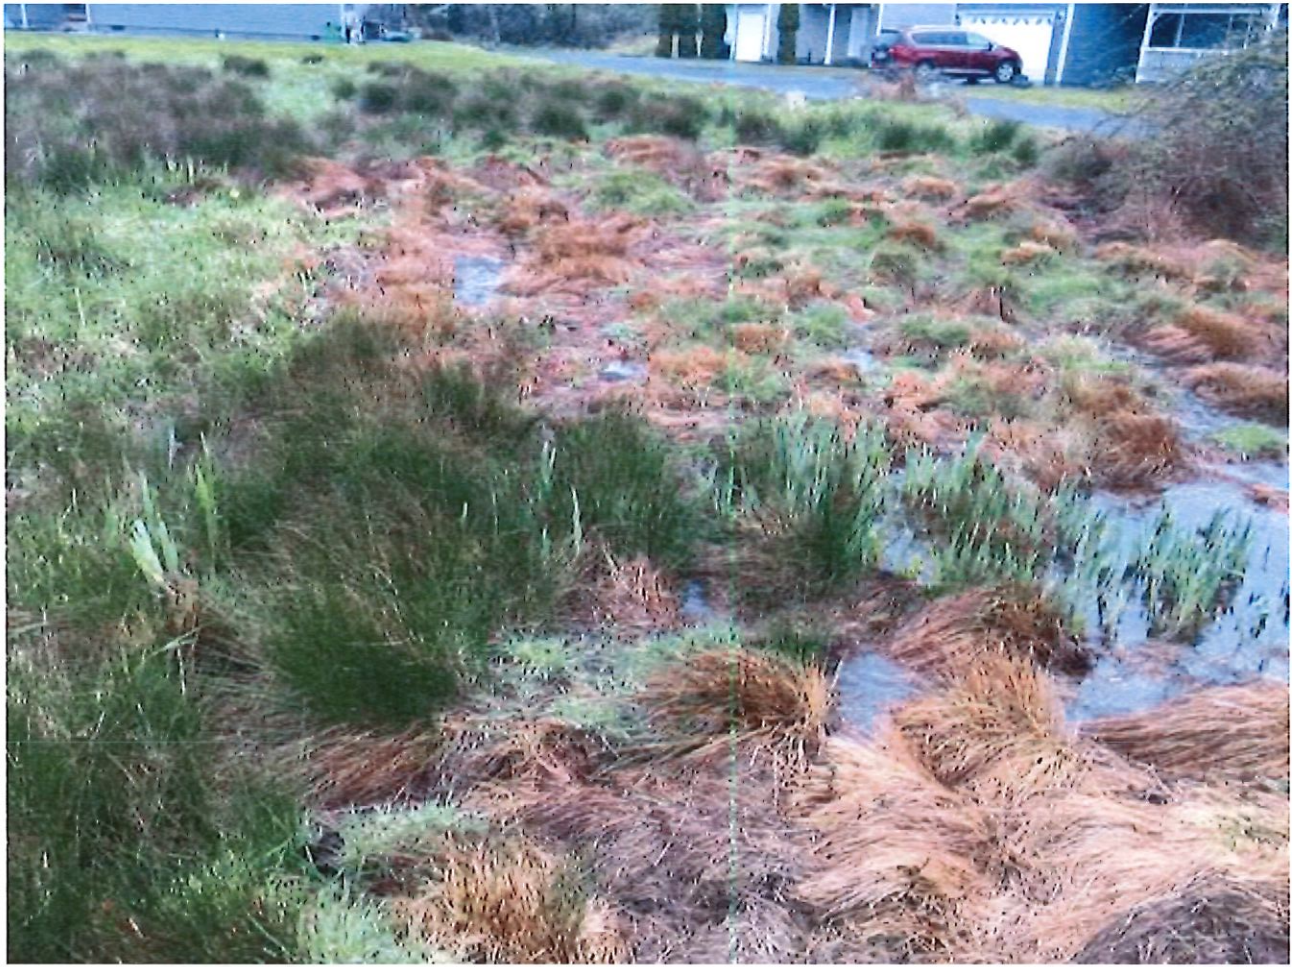
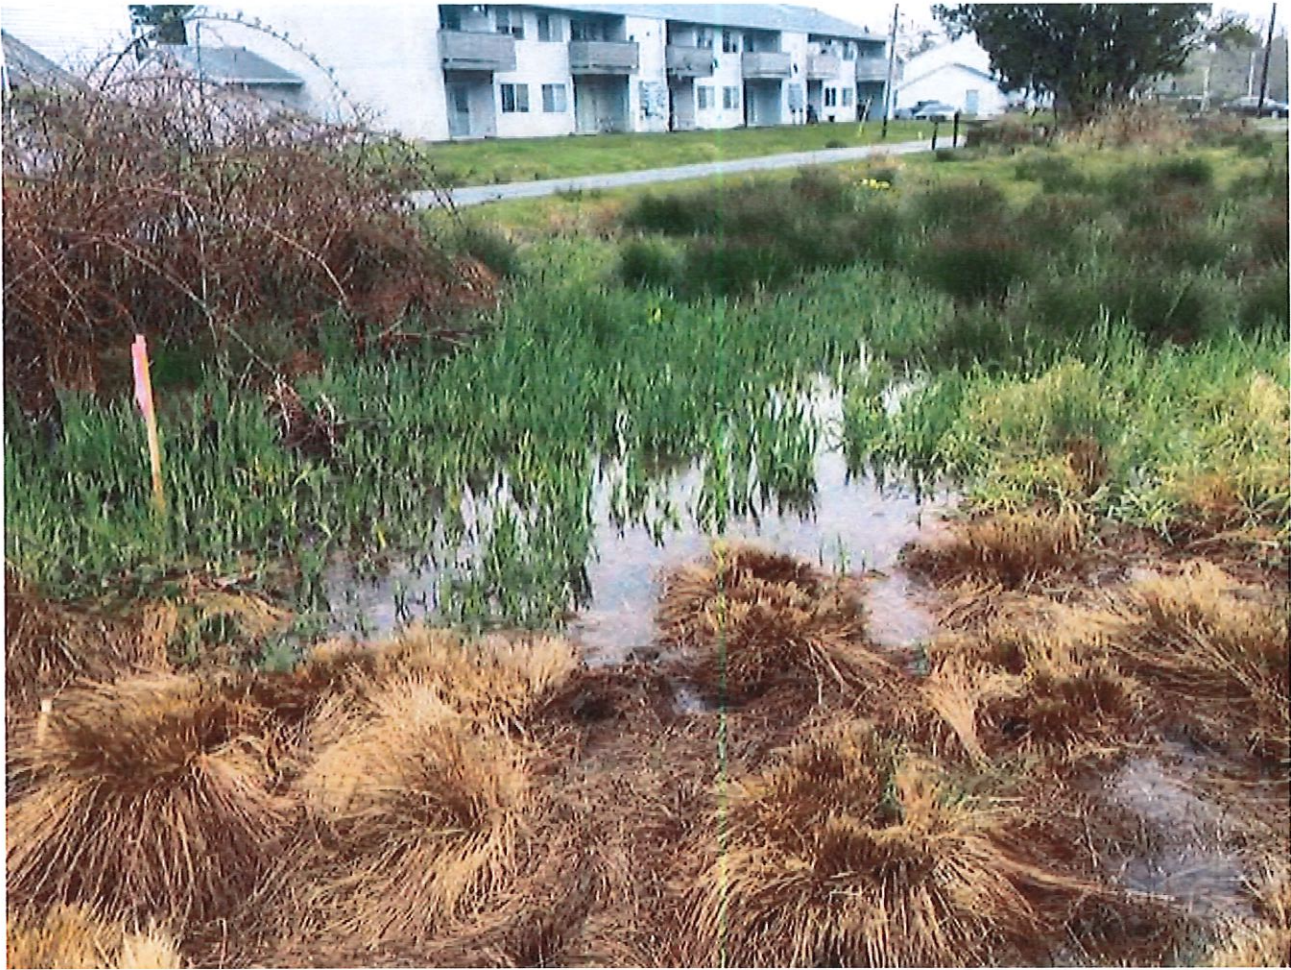
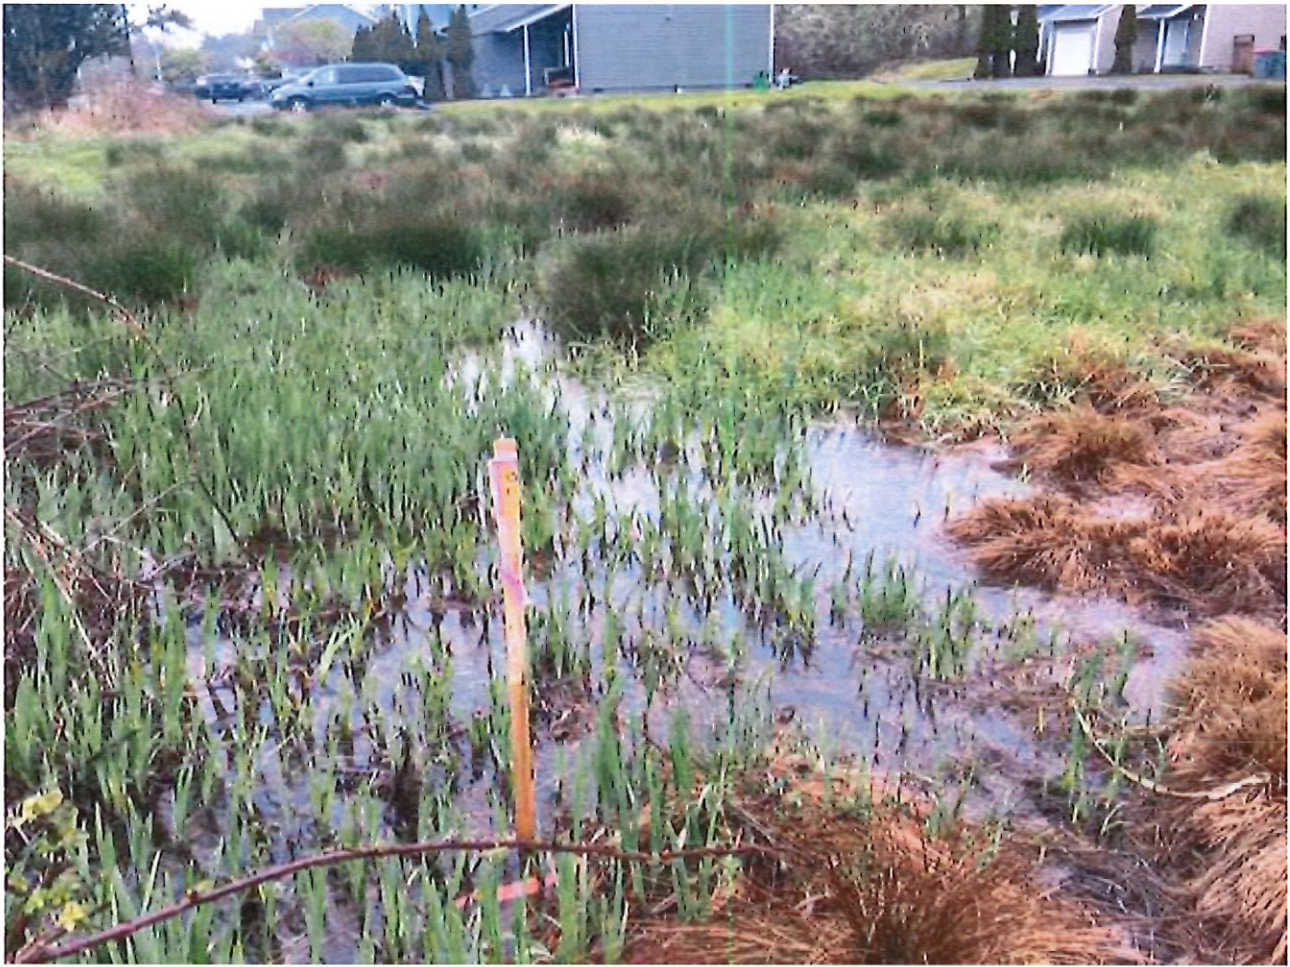
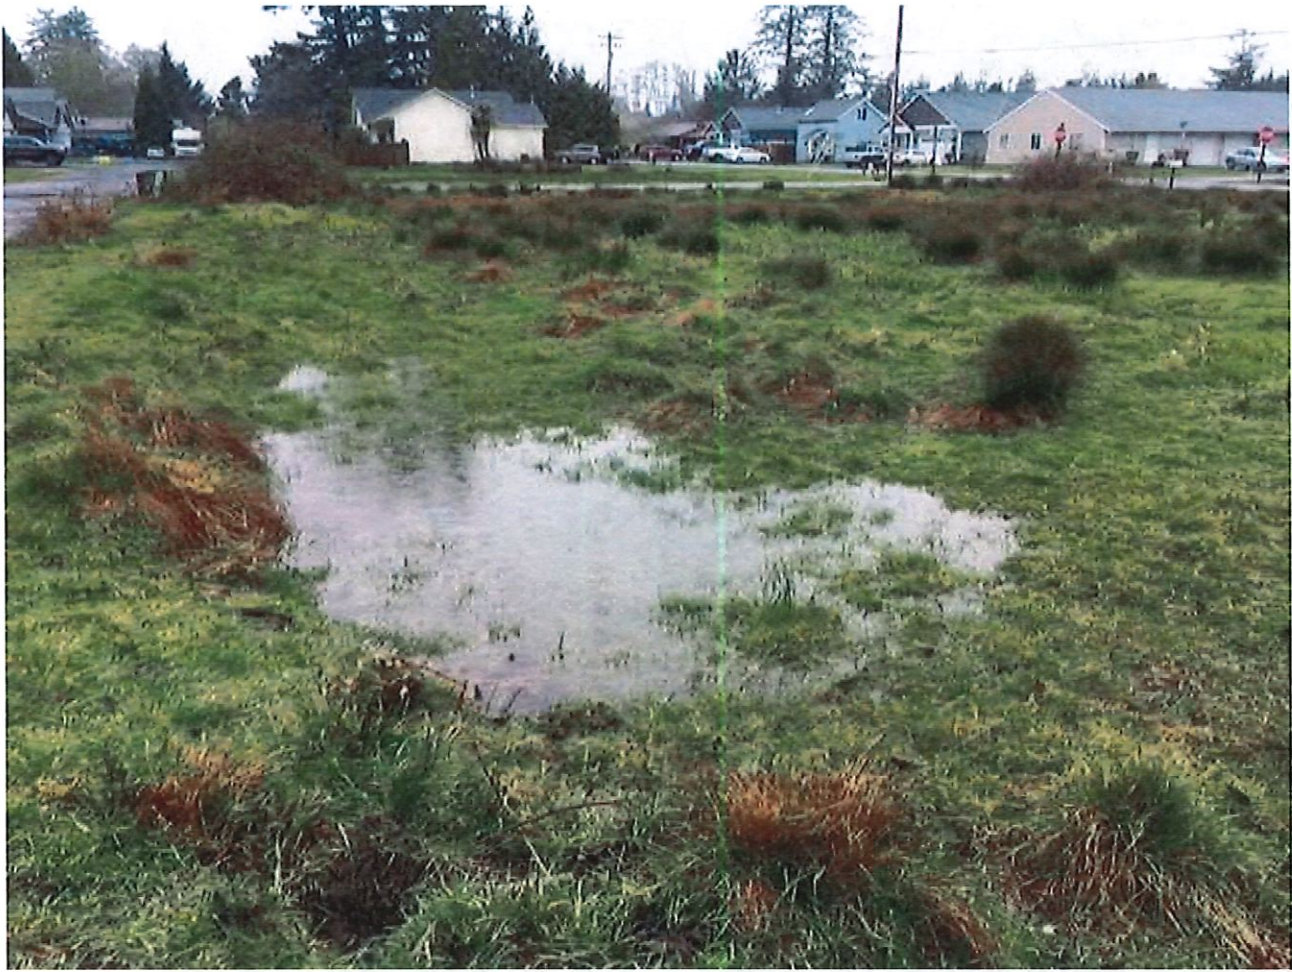
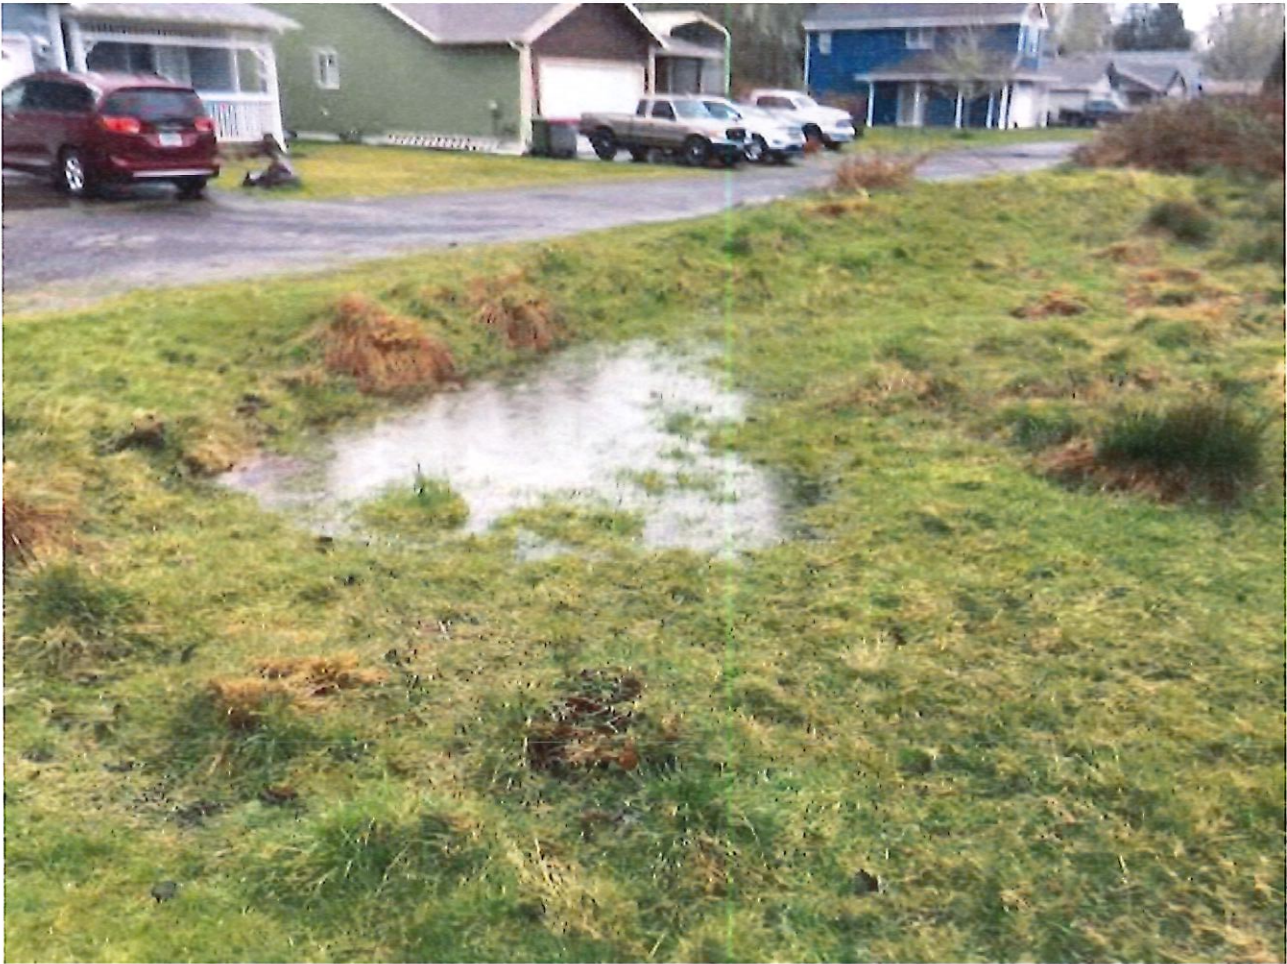
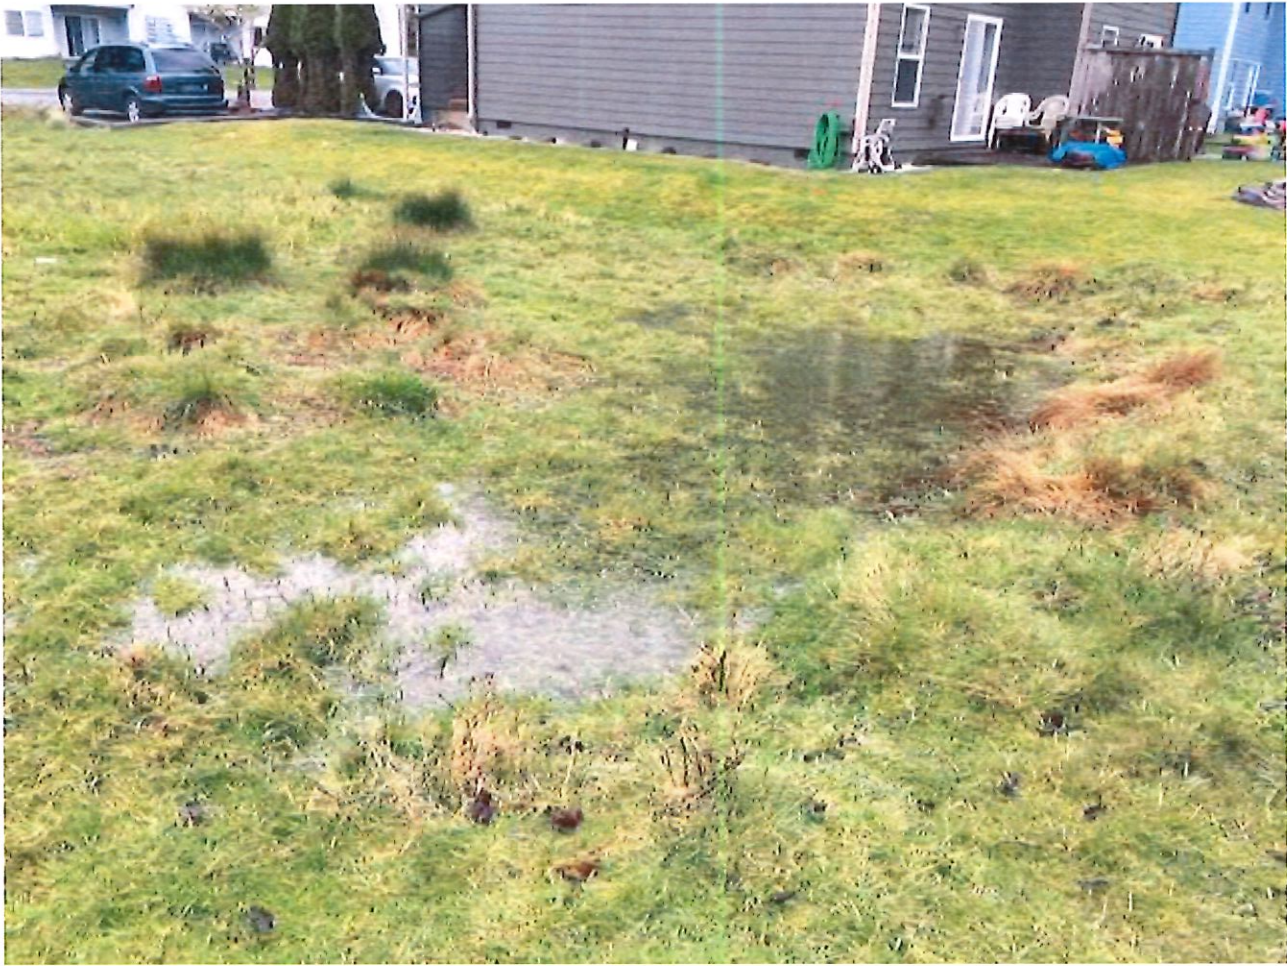
I was only able to access the property via the Fleet Street City Right of Way and the 7th Court Easement. You can see substantial standing water for both Wetlands A by Fleet Street and Wetlands B by the 7th Court in the SE corner of the property. I tried to angle the camera downward rather than from an eye level or kneeling level so you could better see the accumulation.

The total rainfall of the 14 days leading up to my photos is 4.27" – Less than half of what occurred during the same 14day period prior to the 1/6 study day. Why such a difference in standing water & saturation? Even if we add that day's full rainfall of 1.12" to the total, can that really explain such wide variance? Now you can see why I submit these Attachments.

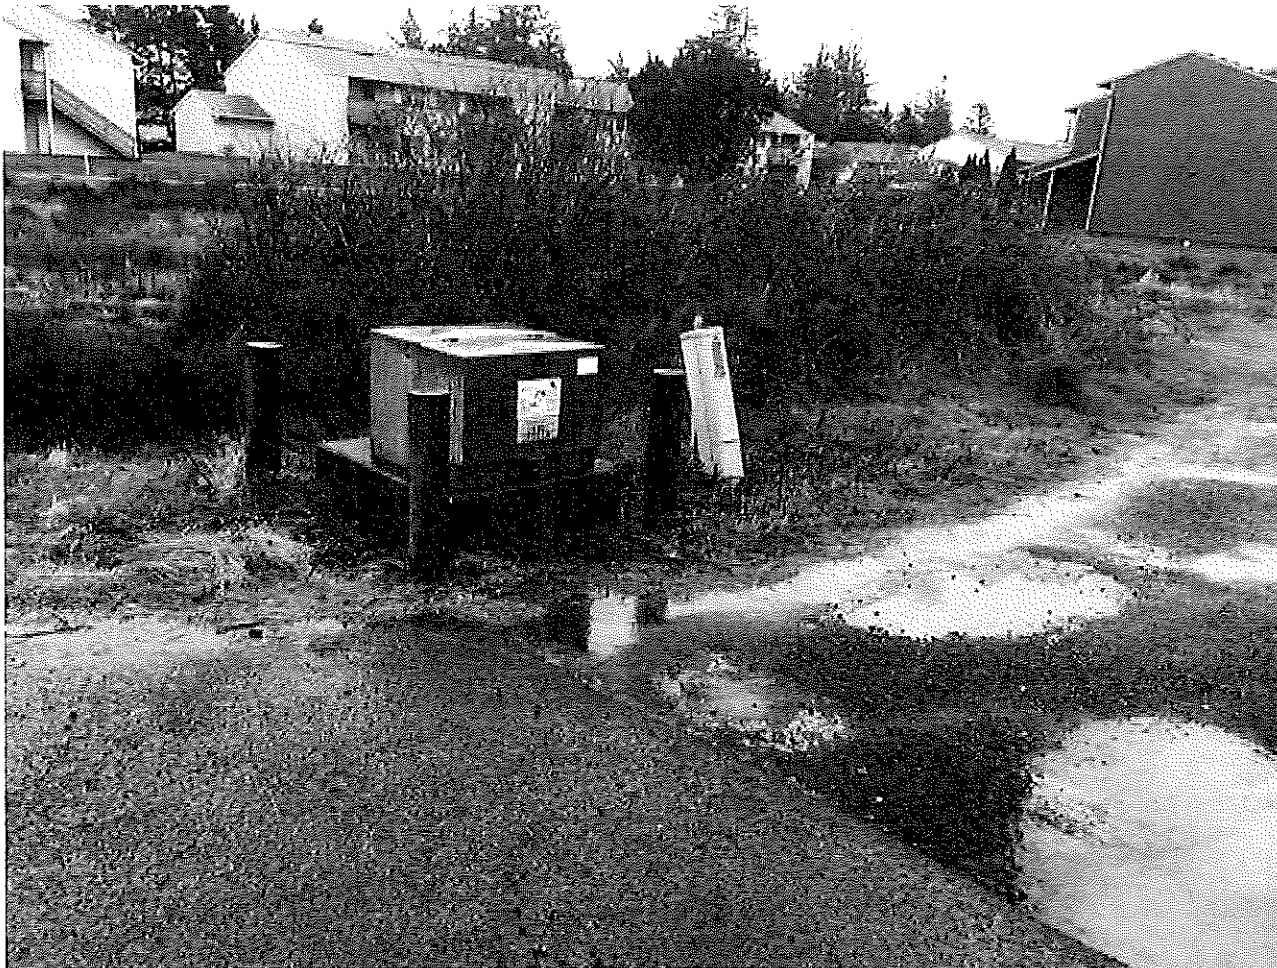
I referred earlier to the applicant's photo of the corner of Fleet St & 7th Court. One of my photos is of the same intersection. I took it so you could see the standing water from the mentioned rainfall compared to a period of dryness. We don't know what date the applicant took the photos or how much, if any, rainfall preceded them.

Rebecca: I think I sent you a video of this corner. It probably won't download properly so I sent you this photo. You can use this to replace the other. Thank you Lisa
